Technical Note N-1172

CORROSION OF MATERIALS IN HYDROSPACE -  
PART VI - STAINLESS STEELS

Fred M. Reinhart

NAVAL CIVIL ENGINEERING LABORATORY  
Port Hueneme, California 93043

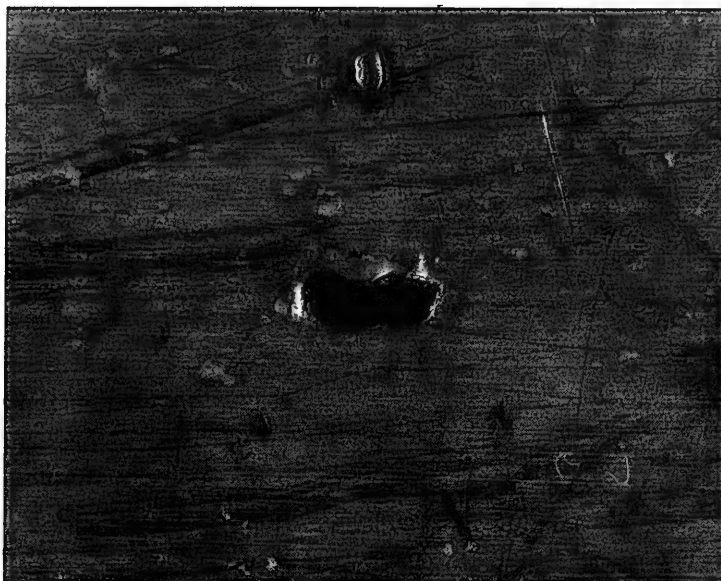
Figure 3. Typical pitting corrosion in stainless steel.

As discussed above, stainless steels generally corrode by pitting, particularly in seawater; therefore, as much as 90 to 95 percent of the exposed surface can be uncorroded. Pitting typical of that usually found in stainless steels is shown in Figure 3. With such low percentages of the total exposed area affected, corrosion calculated from loss in weight as mils per year (MPY) can give a very misleading picture. MPY infers a uniform decrease in thickness, which for stainless steels is not the case.

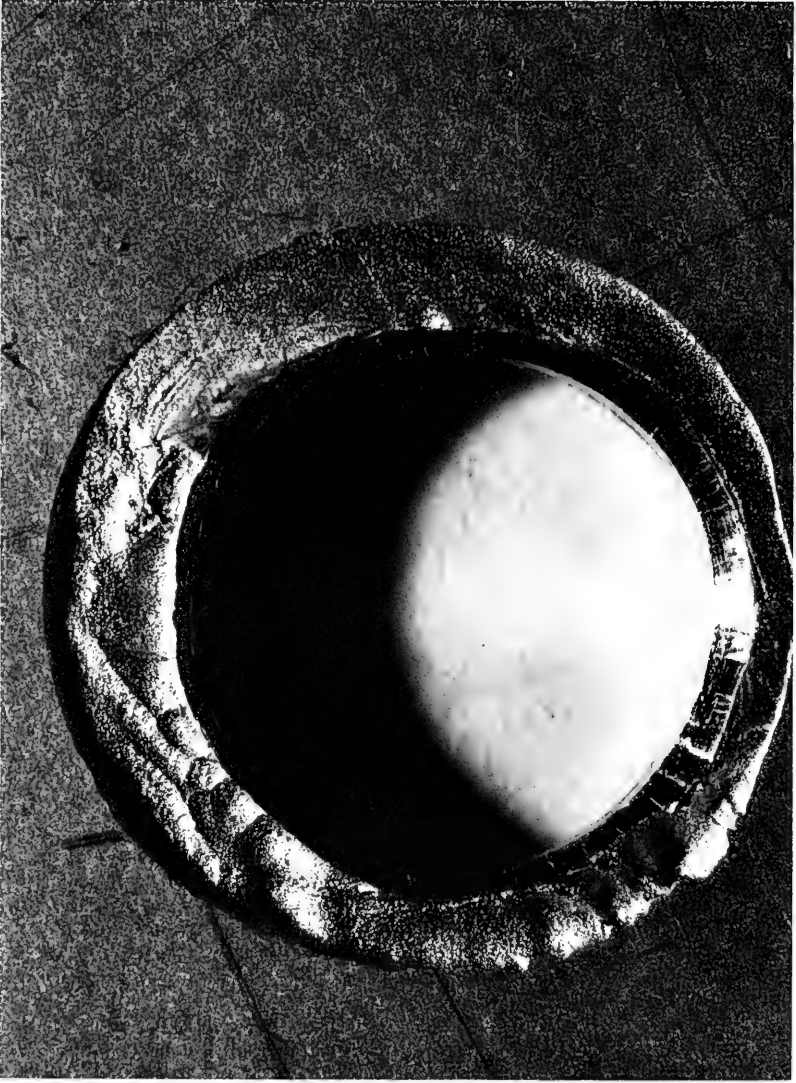
Figure 5. Crevice corrosion typical of that found in stainless steels.

Another manifestation of localized attack in stainless steels is oxygen concentration cell corrosion in crevices (usually known as crevice corrosion). An illustration typical of crevice corrosion in stainless steels is shown in Figure 5. This type of corrosion occurs underneath deposits of any kind on the metal surface, underneath barnacles and at the faying surfaces of a joint. The area of stainless steel which is shielded from the surrounding solution becomes deficient in oxygen, thus creating a difference in oxygen concentration between the shielded and unshielded areas. An electrolytic cell is created with a difference of potential being generated between the high and low oxygen concentration areas with the low oxygen concentration area becoming the anode of the cell.
